Churchill Valley Greenway

Conceptual Planning Report

January 2022

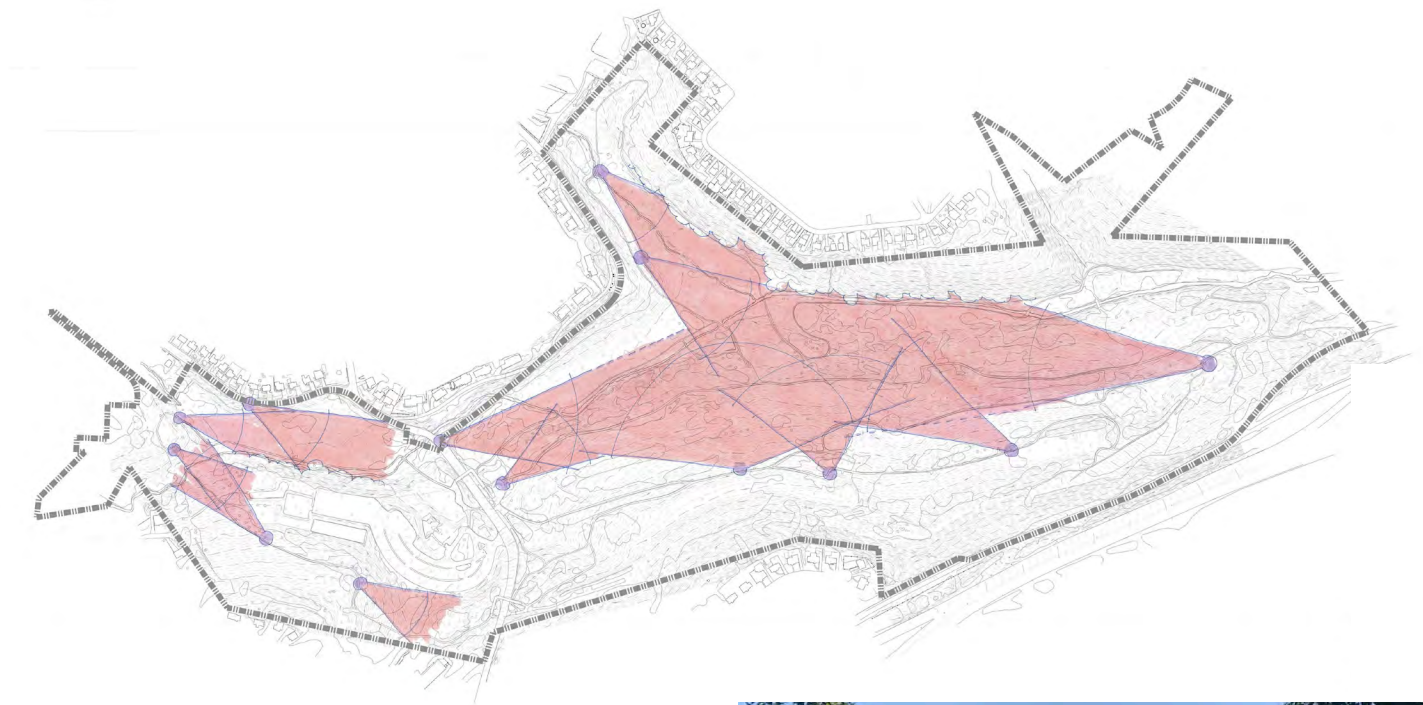
Existing View Corridors

One of the dramatic features of the property is the long-distance views down the former manicured golf fairways which have evolved into meadow. The purple circles indicate locations on the property where these view corridors are most evident.

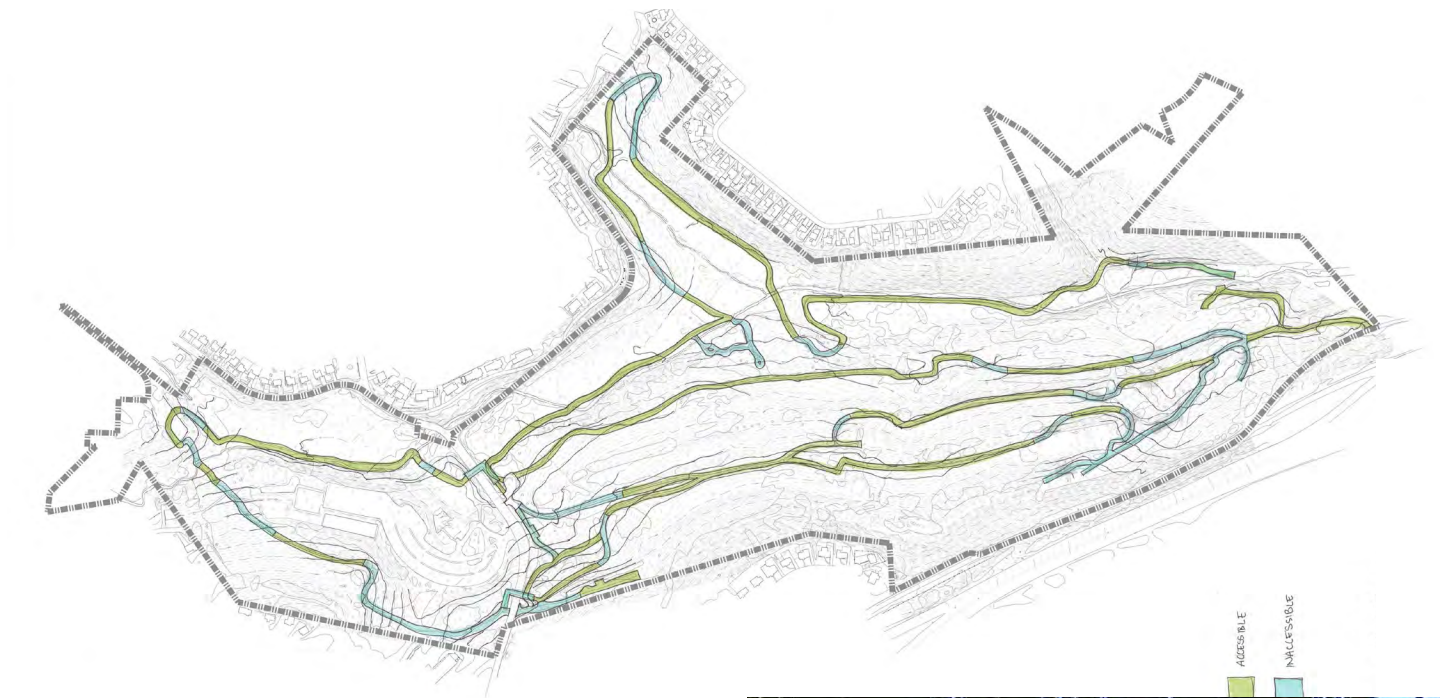
Existing Trails and Pathways

This diagram illustrates existing trails which are former golf cart pathways. Green indicates handicap accessible trails and blue indicates non-handicap accessible trails. Trails within the flood plain of Chalfant Run will need to be removed for restoration to take place.

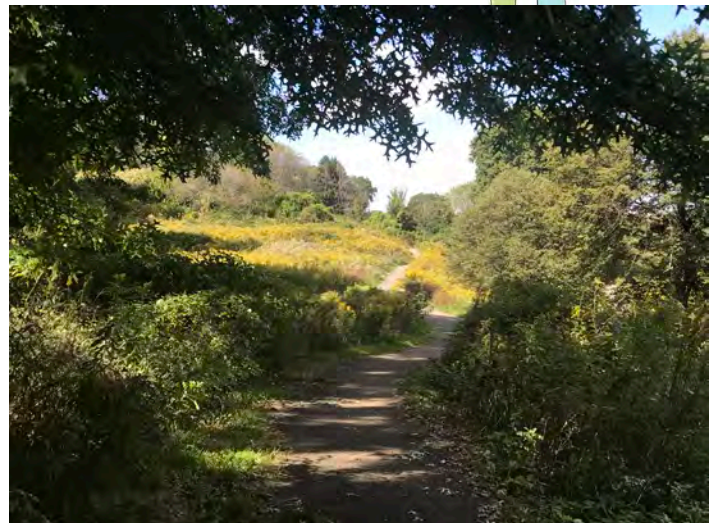
Portions of some existing trails are handicap accessible

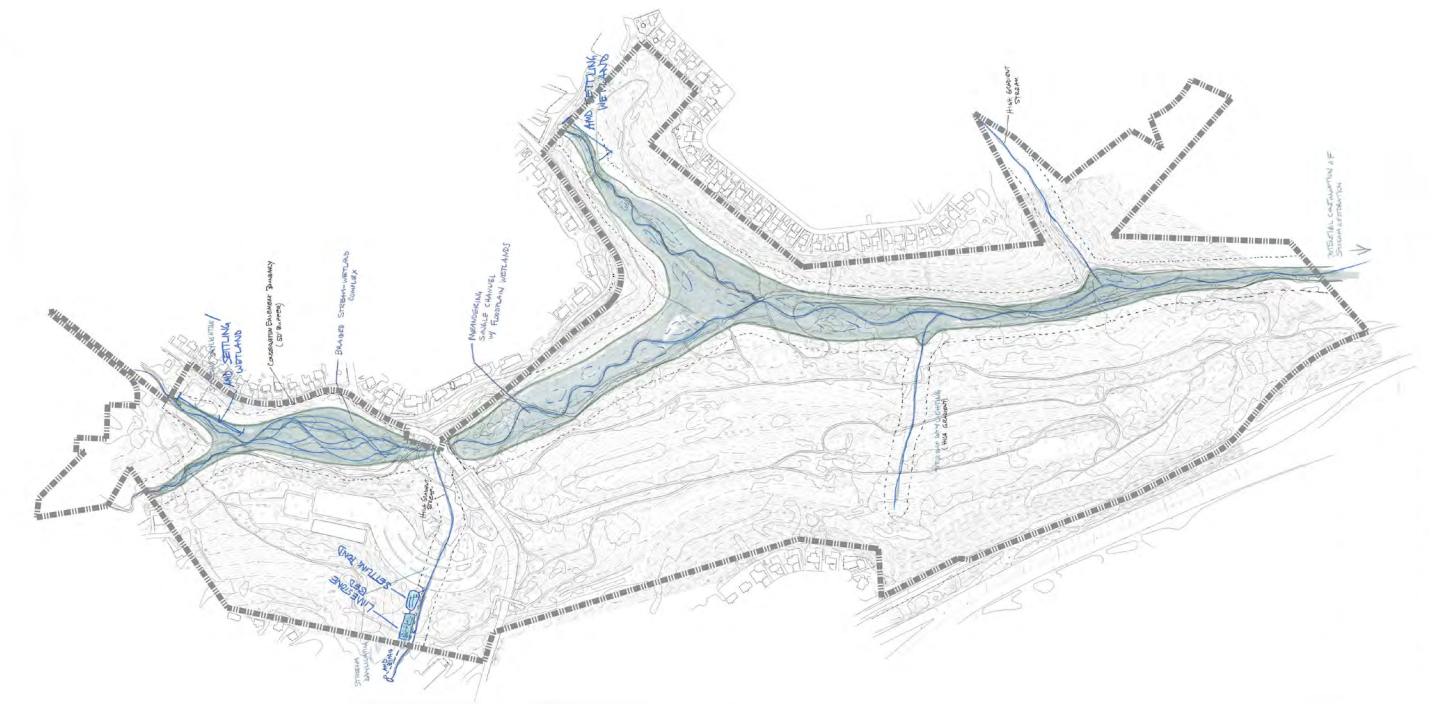
Abandoned Mine Drainage and Stream Restoration Ideas

There are three proposed locations for new facilities to treat AMD before water is discharged back into a restored Chalfant Run channel. The floodplain of the current stream would be excavated to remove legacy sediment and a new, meandering channel constructed.

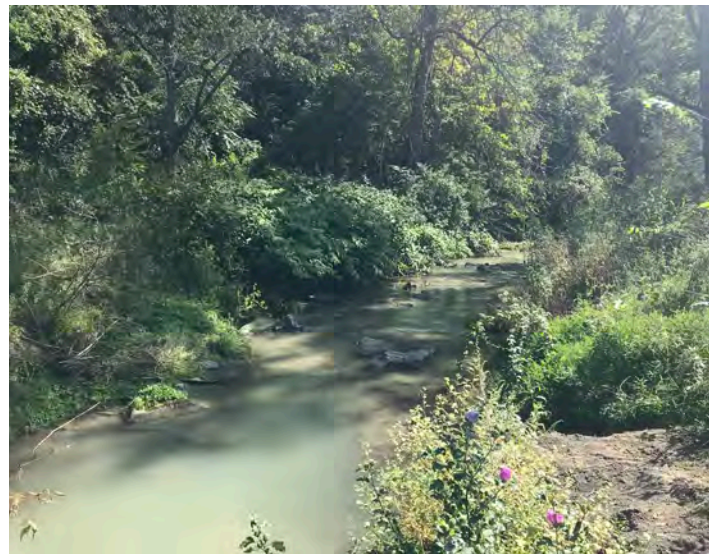
Grey color is aluminum sediment which although non-toxic, is harming the instream habitat of Chalfant Run

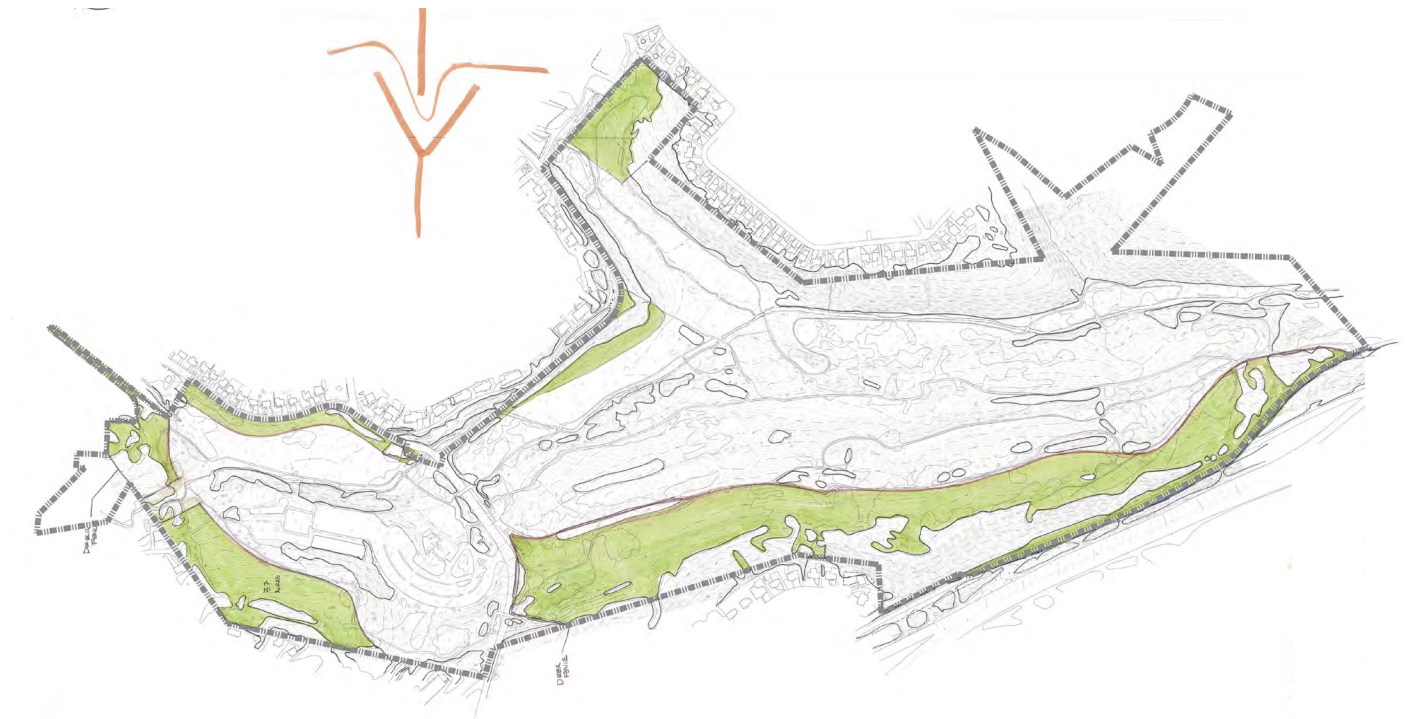
Reforestation Ideas

This diagram suggests reforesting select areas of the property to enhance/expand existing forest, buffer adjacent property and create additional woodland habitat. Reforestation efforts will not only sequester carbon but also reduce the amount of meadow that needs to be maintained.

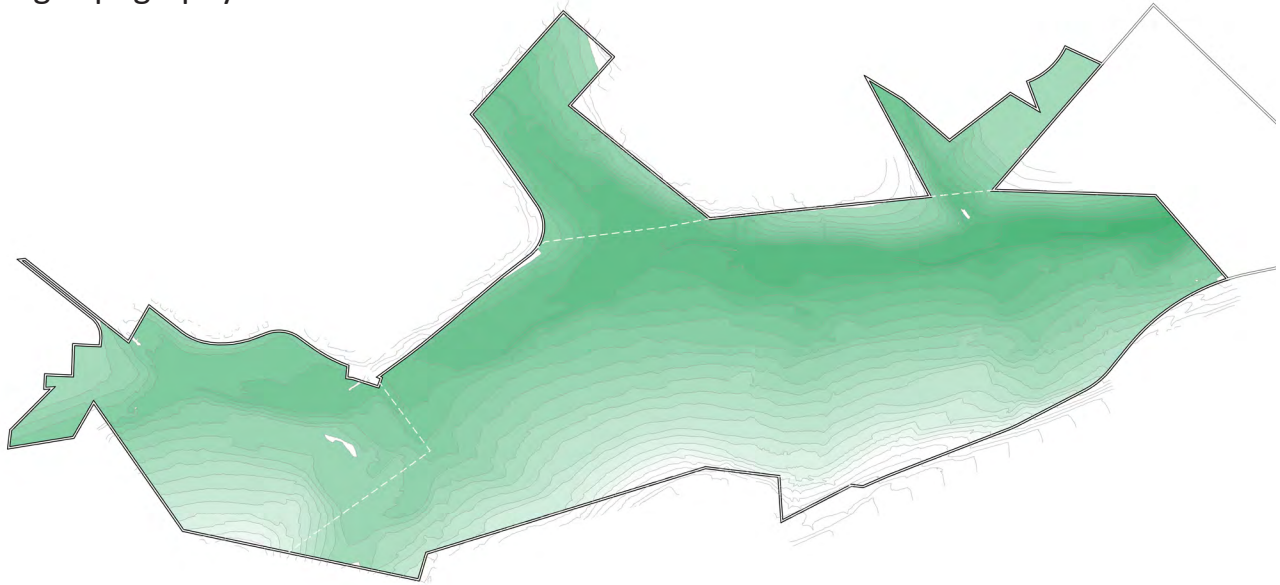
Existing Topography

Formerly graded as a golf course, the property has relatively gentle slopes that descend towards Chalfant Run and modest high and low points that were formerly tees or greens. The topography helps define the property and contributes to the long vistas that are so unique to this property.

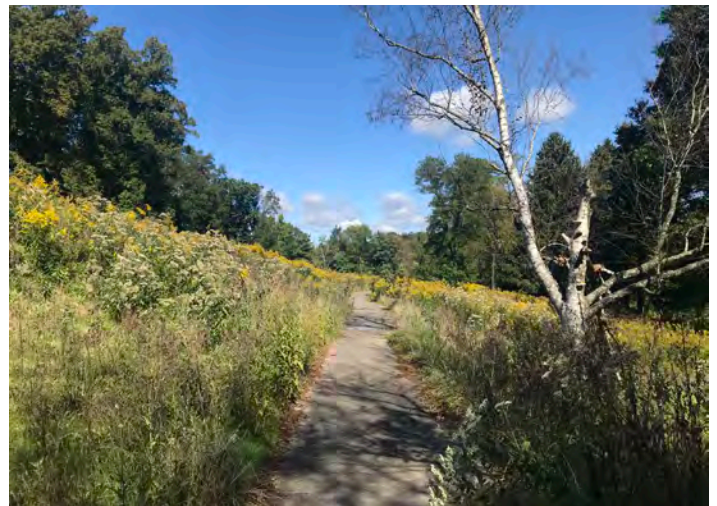
Former cart path downslope from former tee box

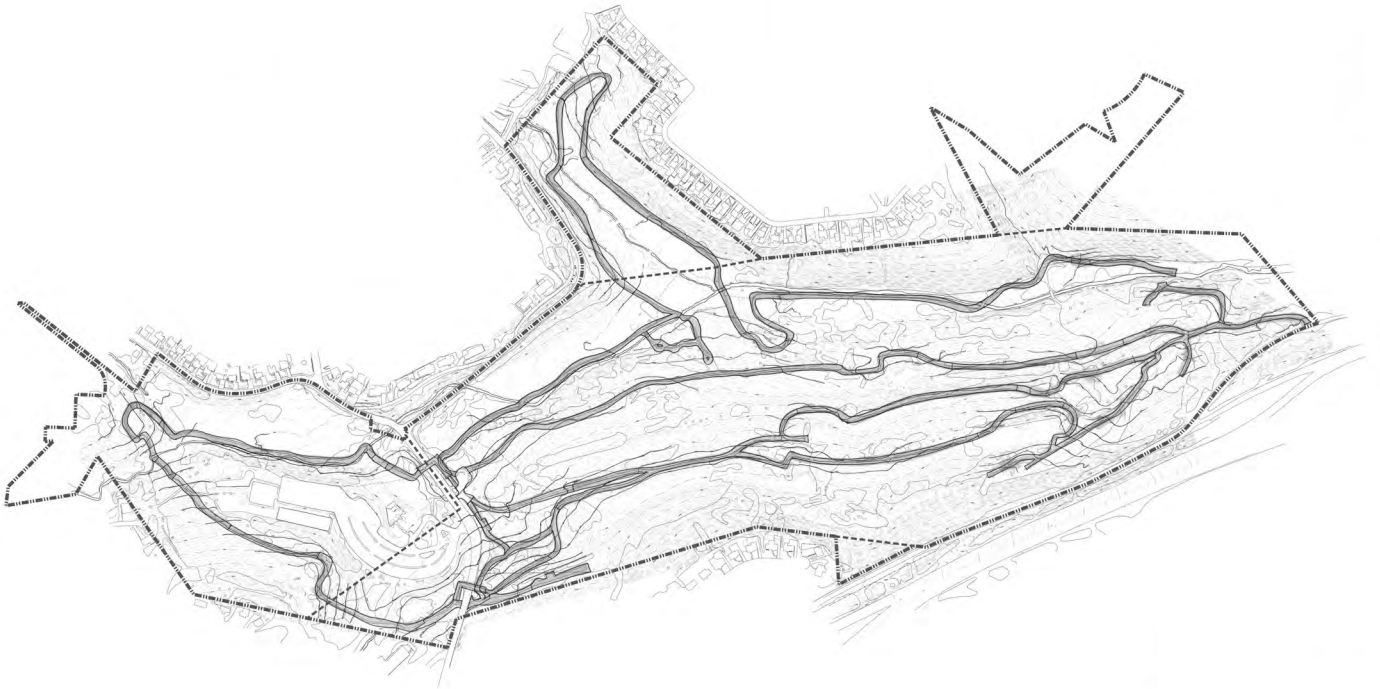
Existing Infrastructure

The property contains remnant infrastructure (parking lots, utilities, bridges, trails) that were necessary for the former golf course. To the greatest extent possible, this infrastructure can be re-used and is one of the property's greatest assets. Golf cart bridges over Chalfant Run will be removed when stream restoration occurs, and only select crossings will be reestablished.

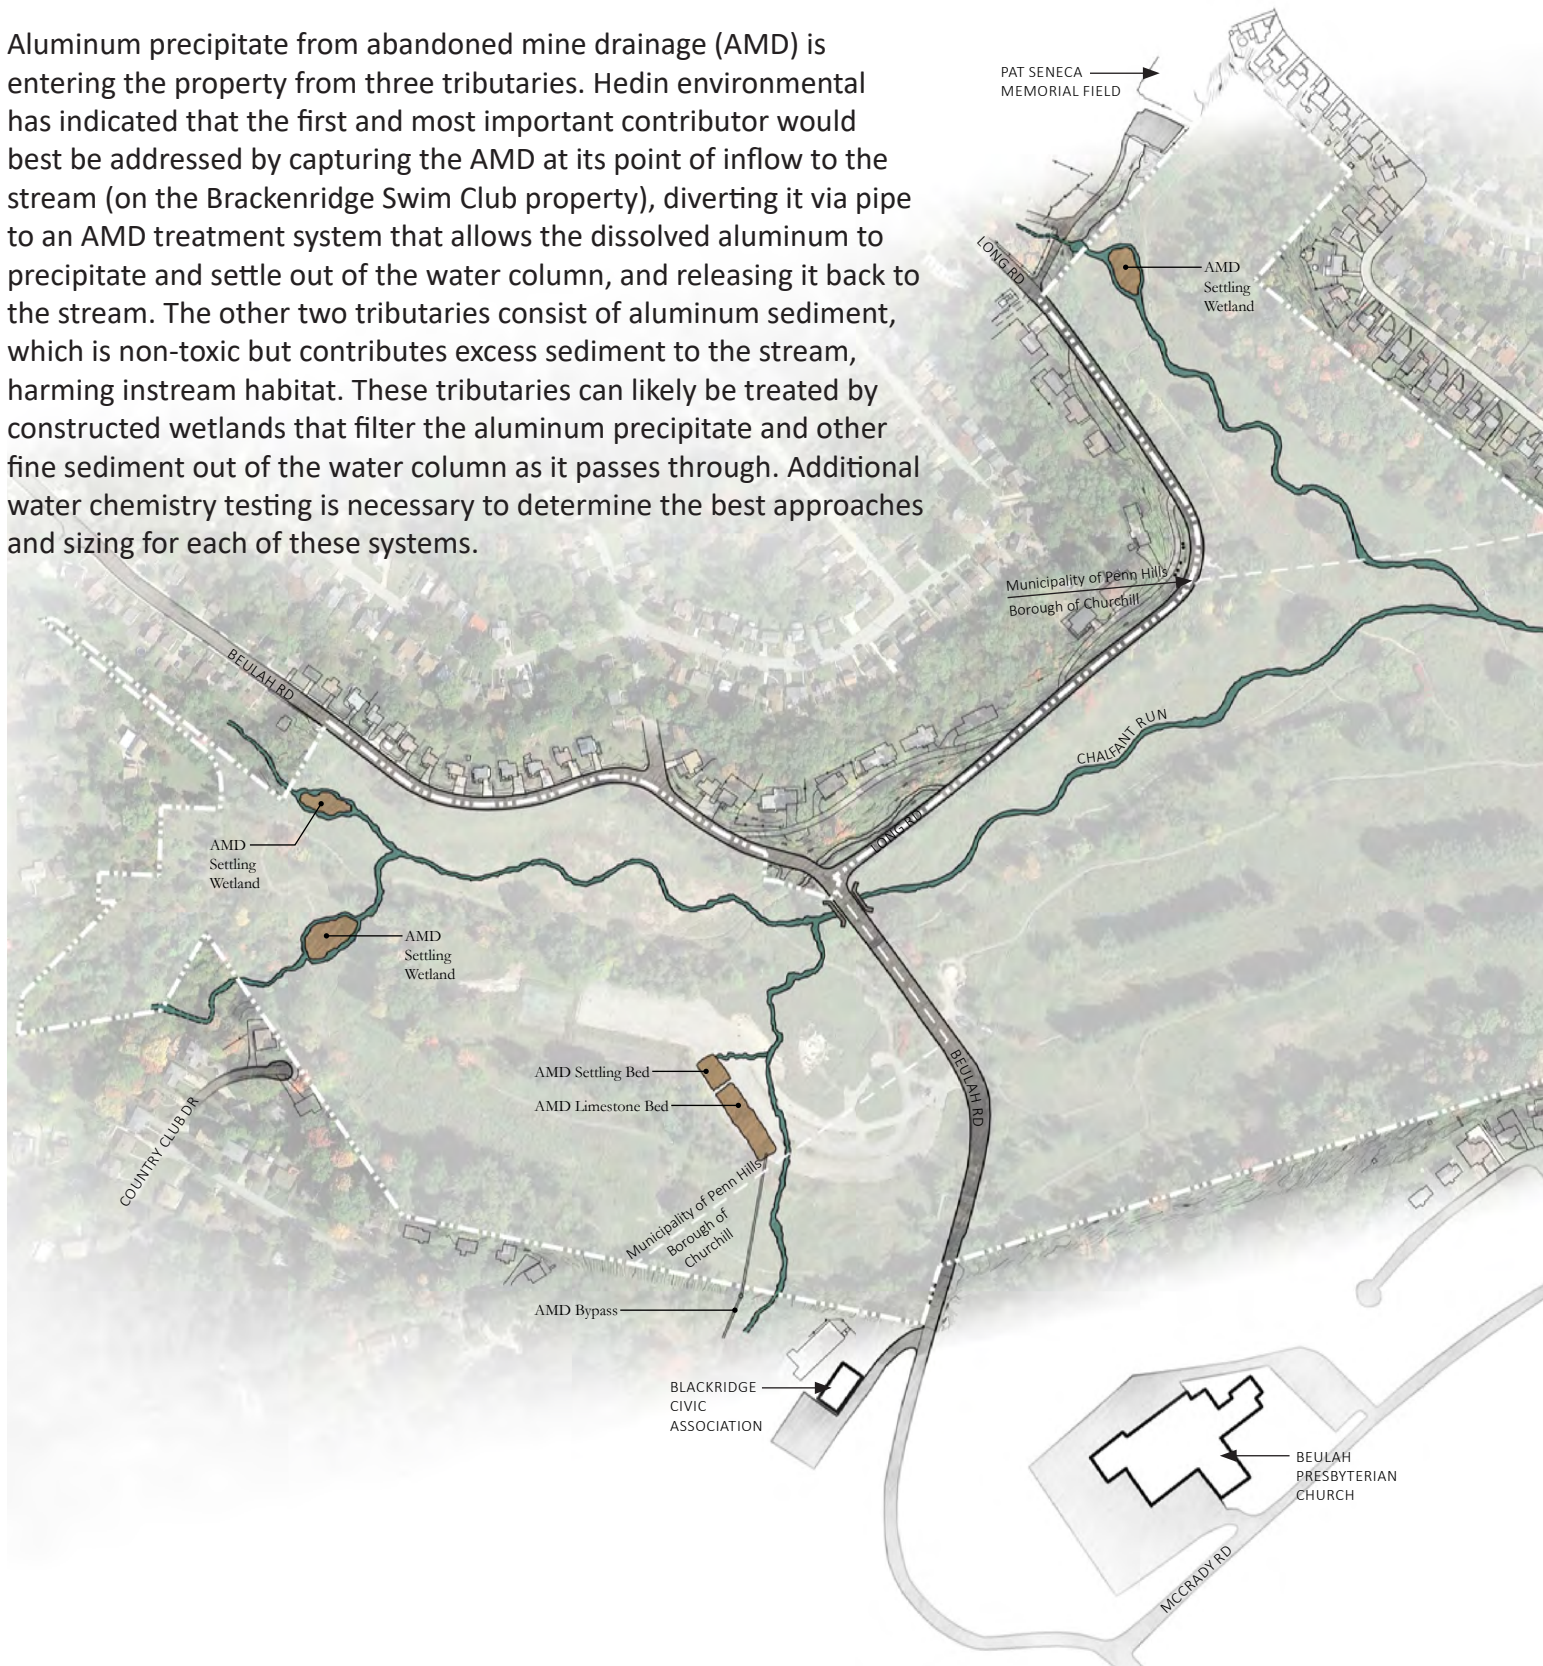
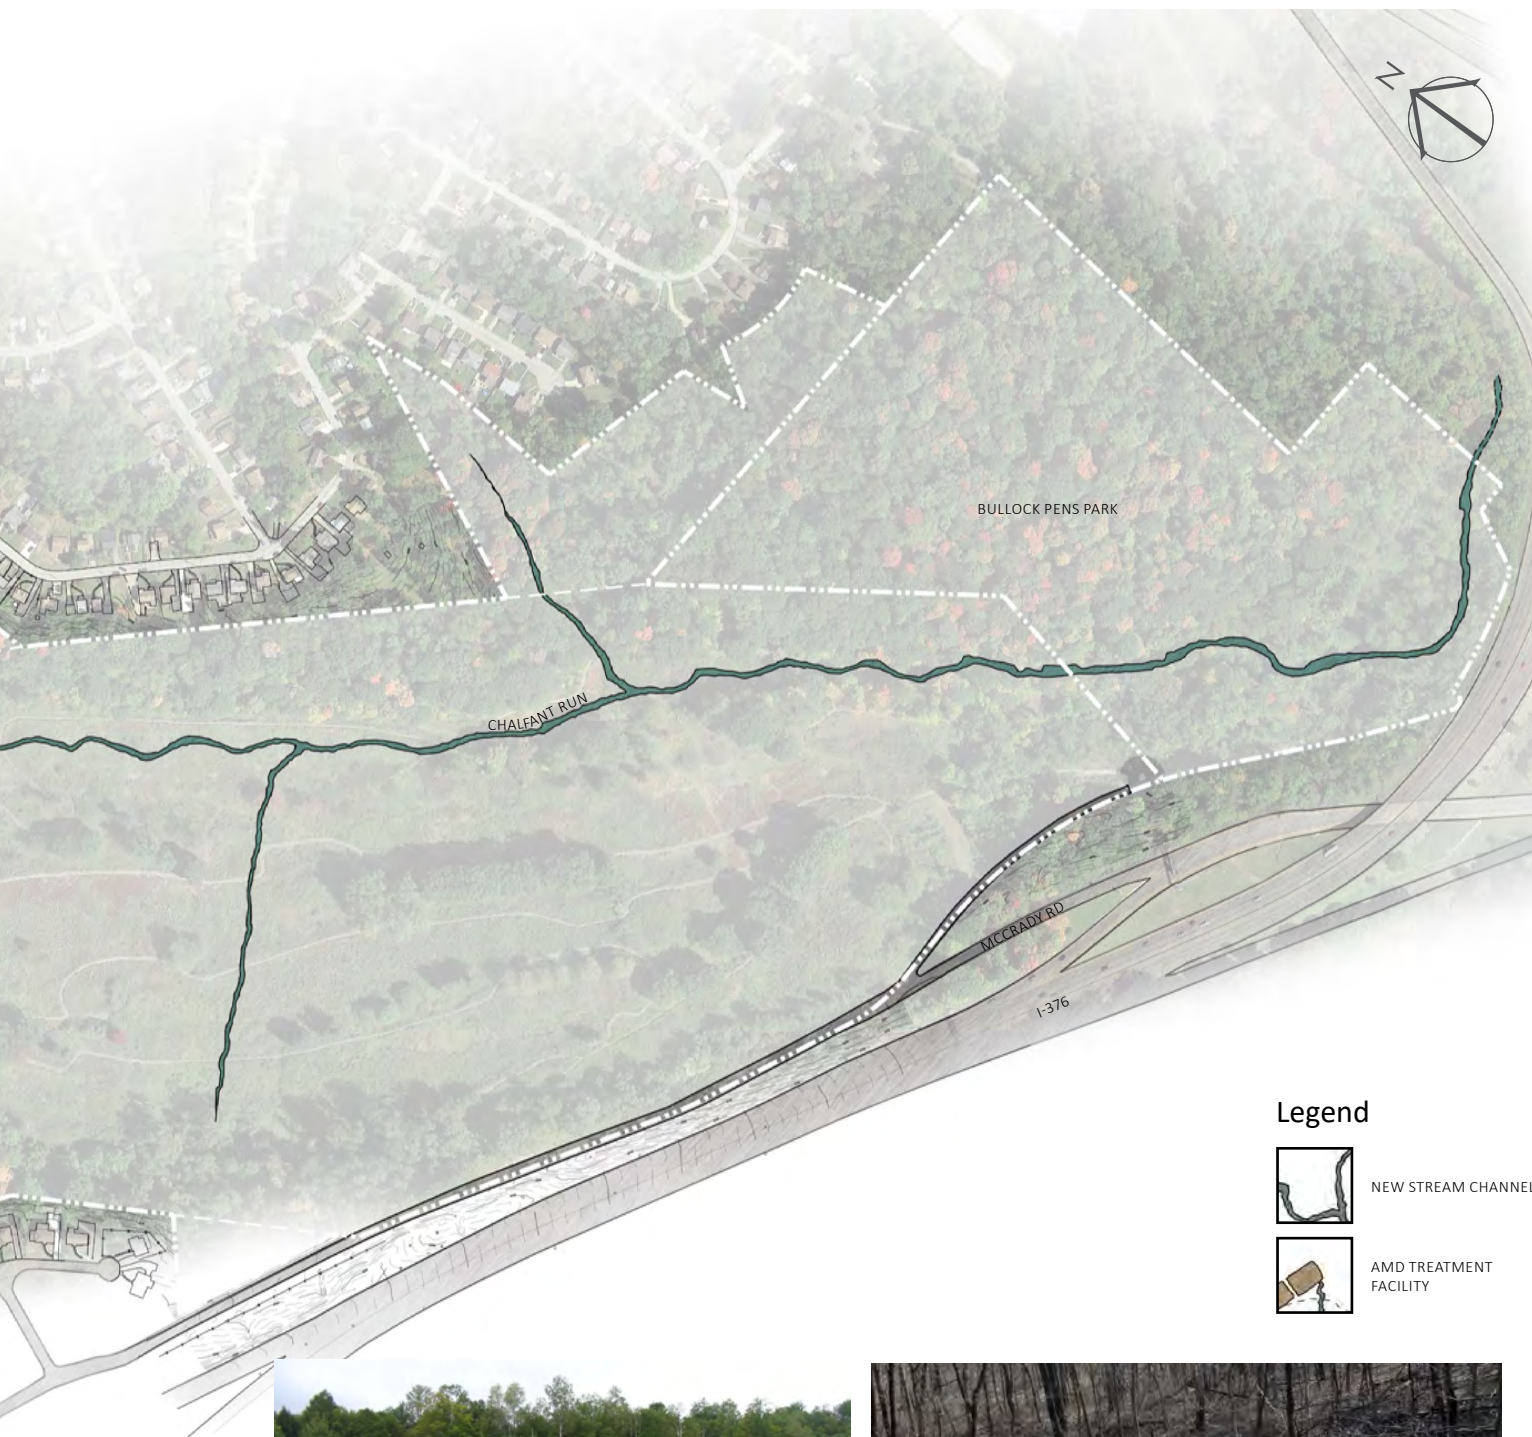
Proposed Abandoned Mine Drainage Strategies

Aluminum precipitate from abandoned mine drainage (AMD) is entering the property from three tributaries. Hedin environmental has indicated that the first and most important contributor would best be addressed by capturing the AMD at its point of inflow to the stream (on the Brackenridge Swim Club property), diverting it via pipe to an AMD treatment system that allows the dissolved aluminum to precipitate and settle out of the water column, and releasing it back to the stream. The other two tributaries consist of aluminum sediment, which is non-toxic but contributes excess sediment to the stream, harming instream habitat. These tributaries can likely be treated by constructed wetlands that filter the aluminum precipitate and other fine sediment out of the water column as it passes through. Additional water chemistry testing is necessary to determine the best approaches and sizing for each of these systems.

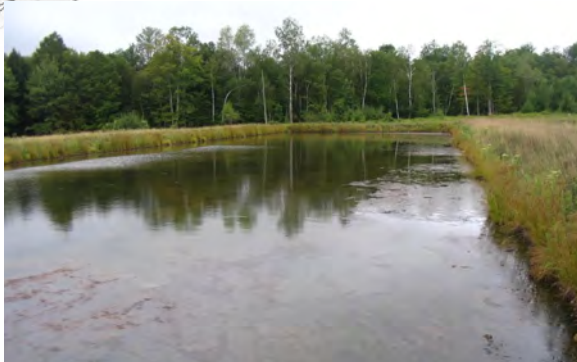
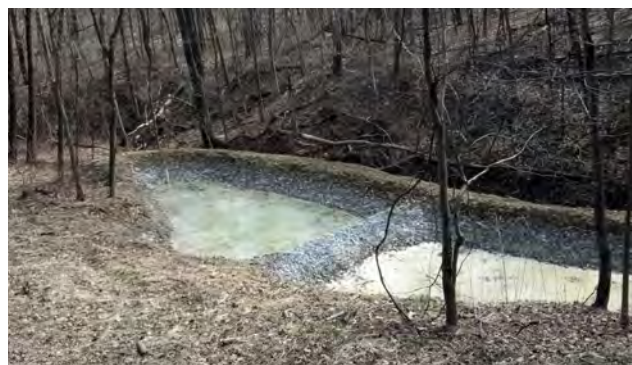
Examples of different techniques to treat low pH (aluminum) abandoned mine drainage

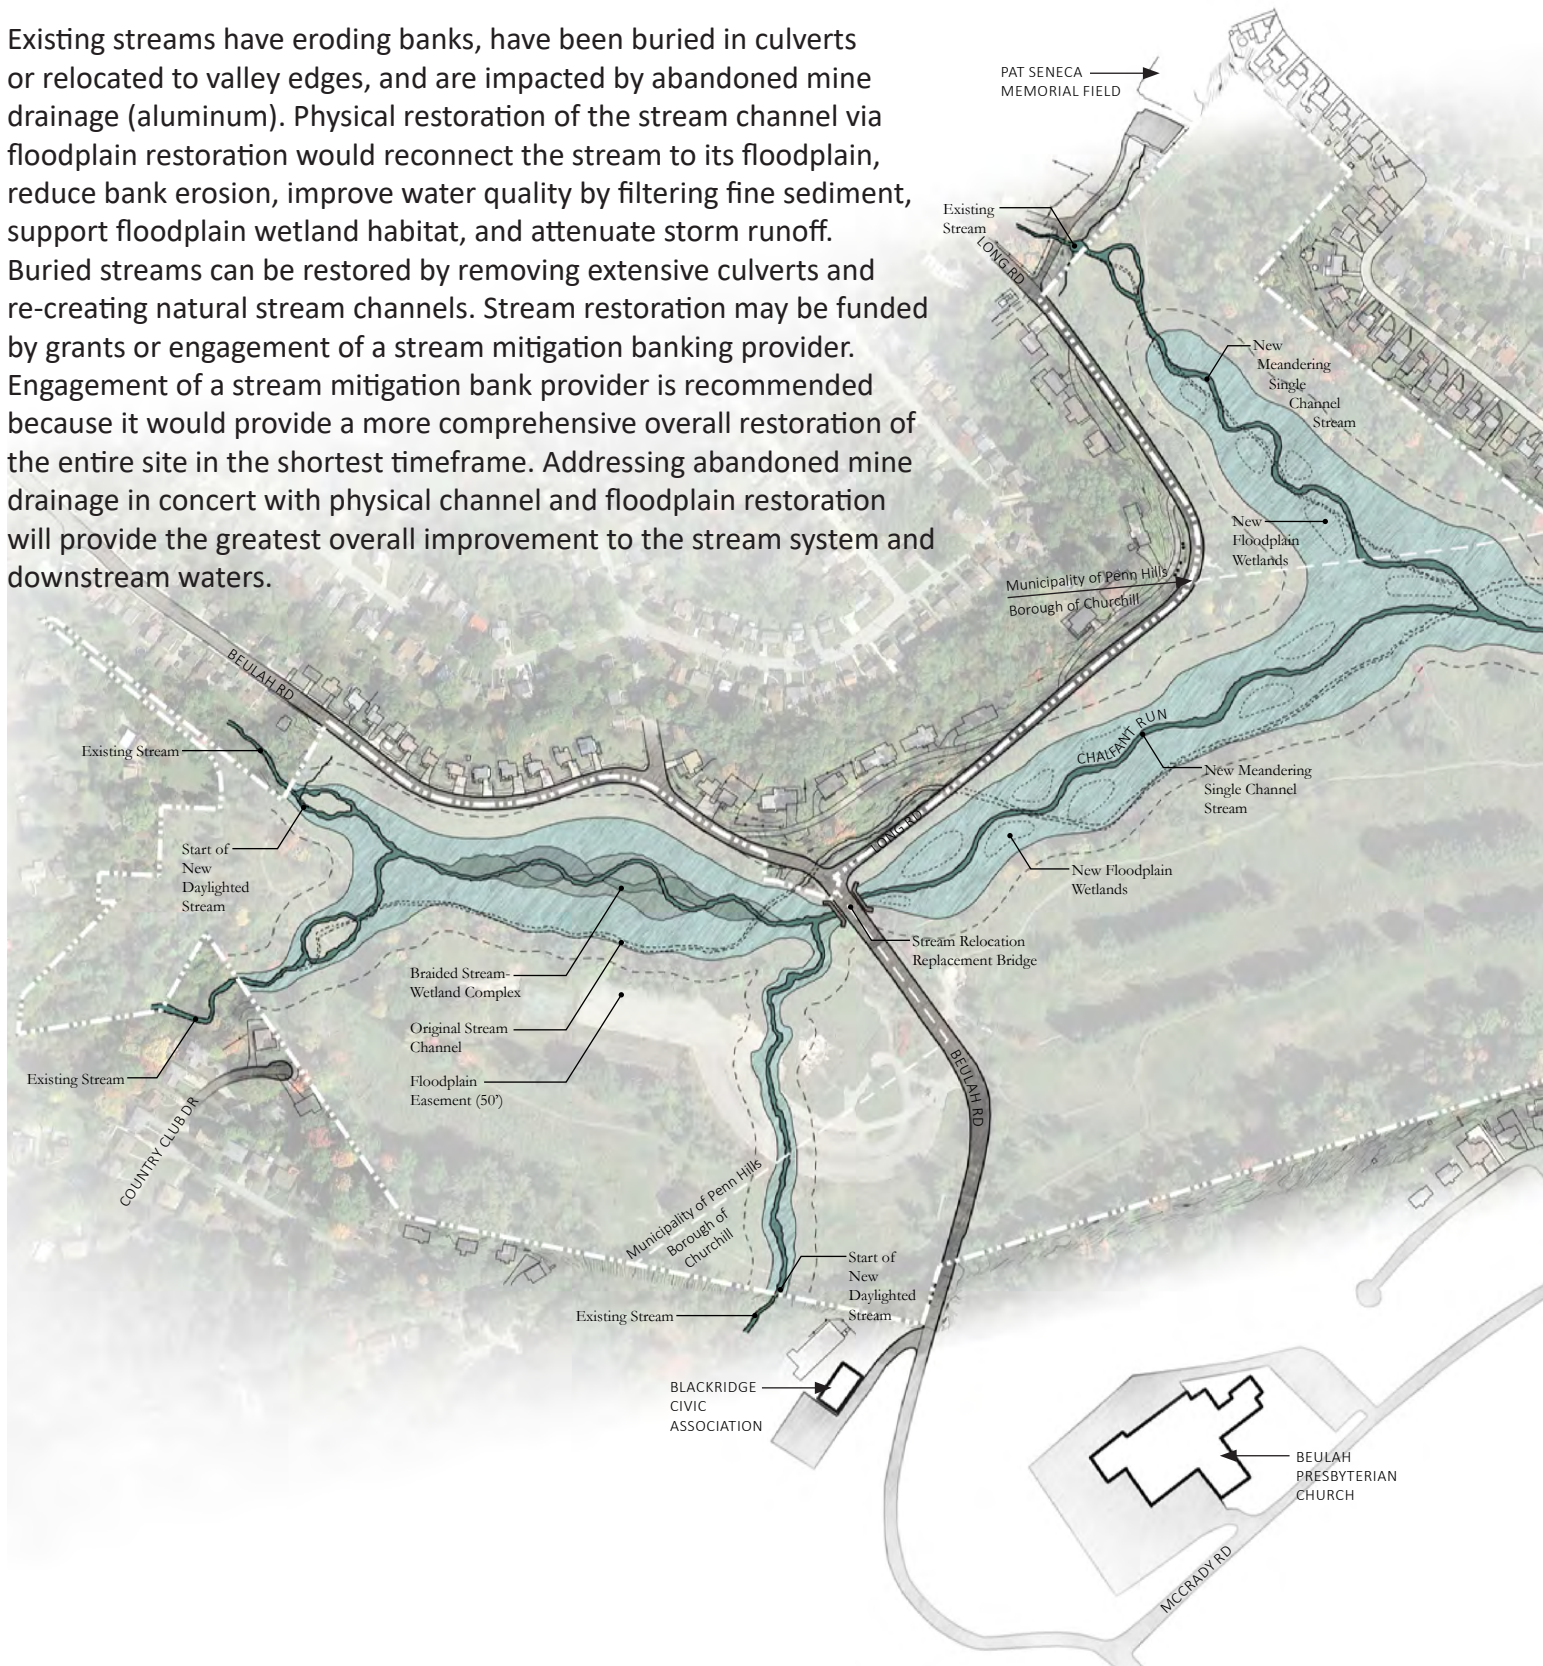
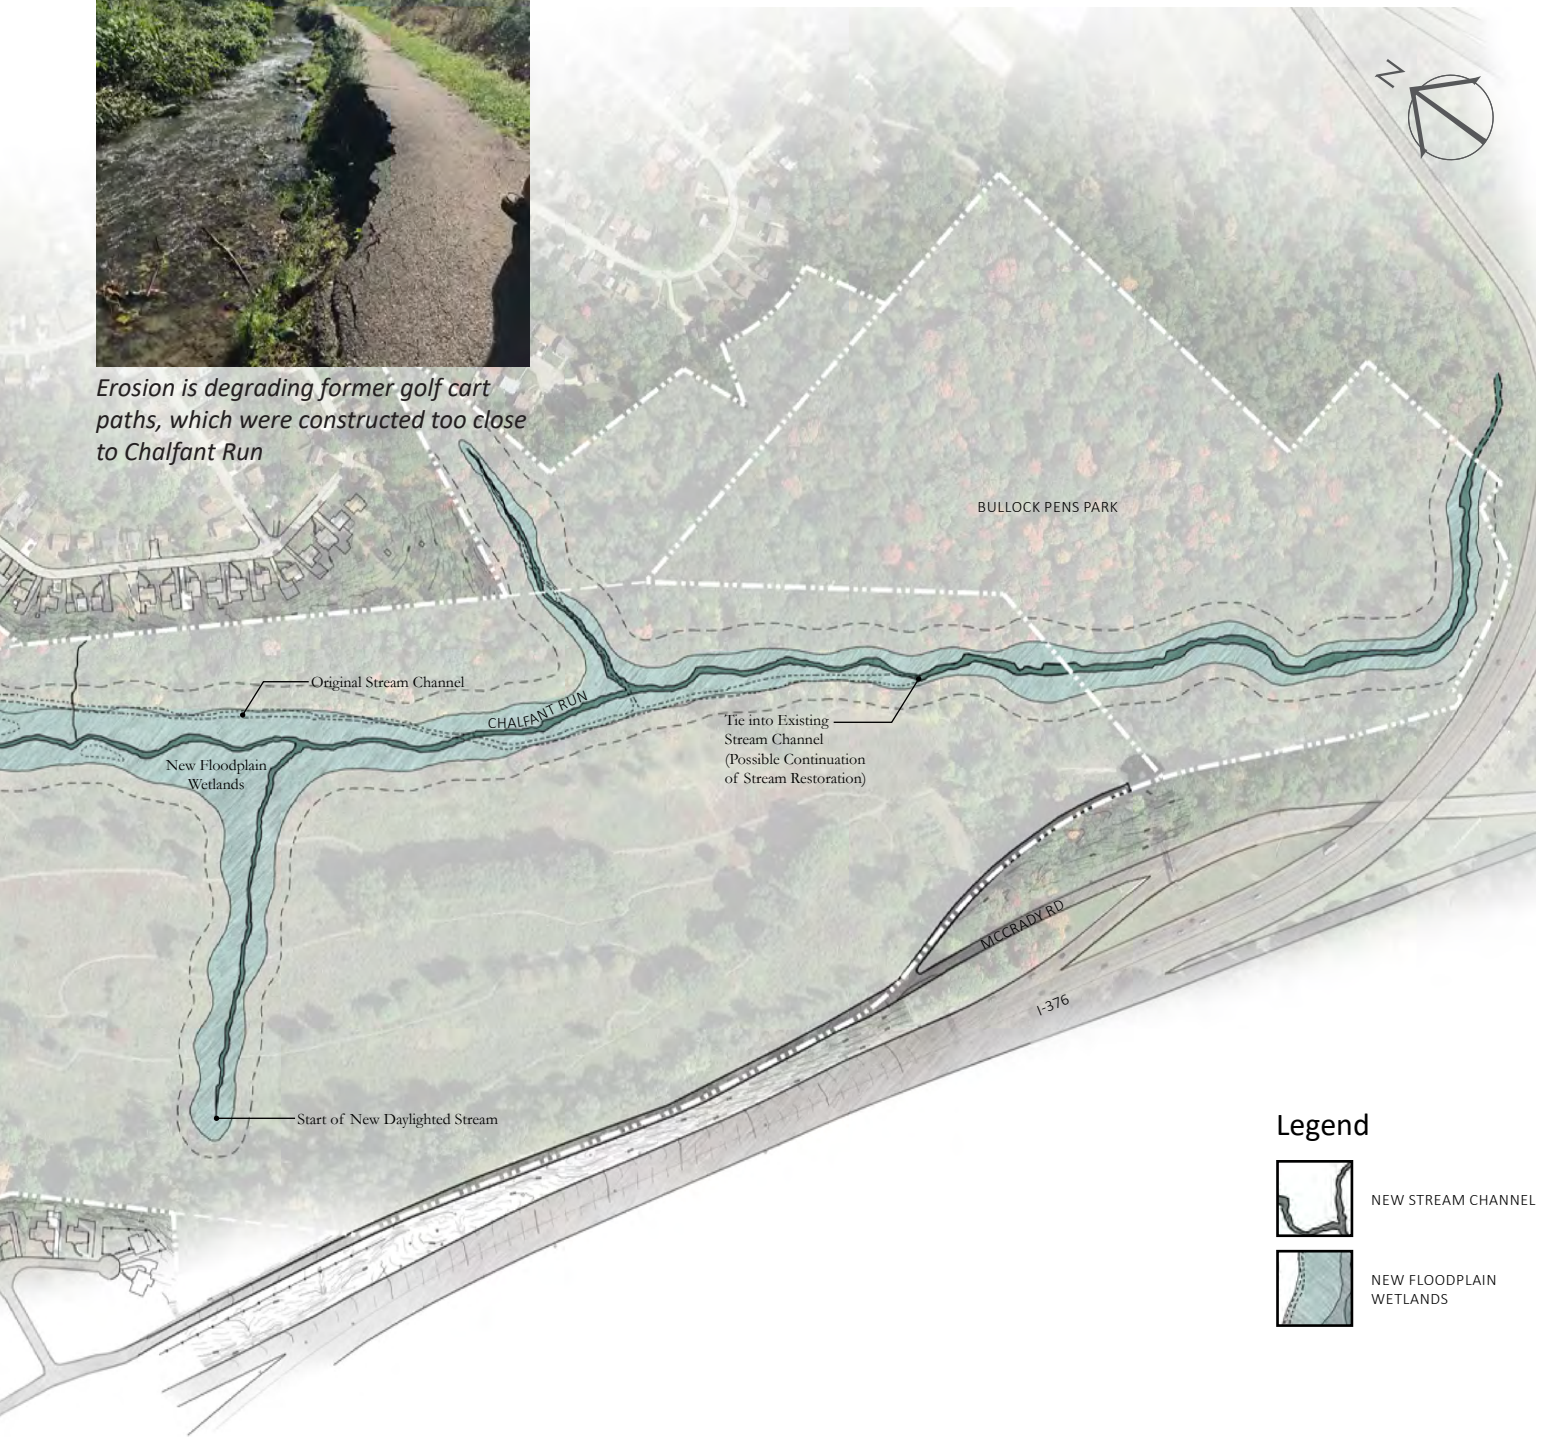
Proposed Stream Restoration Strategies

Existing streams have eroding banks, have been buried in culverts or relocated to valley edges, and are impacted by abandoned mine drainage (aluminum). Physical restoration of the stream channel via floodplain restoration would reconnect the stream to its floodplain, reduce bank erosion, improve water quality by filtering fine sediment, support floodplain wetland habitat, and attenuate storm runoff. Buried streams can be restored by removing extensive culverts and re-creating natural stream channels. Stream restoration may be funded by grants or engagement of a stream mitigation banking provider. Engagement of a stream mitigation bank provider is recommended because it would provide a more comprehensive overall restoration of the entire site in the shortest timeframe. Addressing abandoned mine drainage in concert with physical channel and floodplain restoration will provide the greatest overall improvement to the stream system and downstream waters.

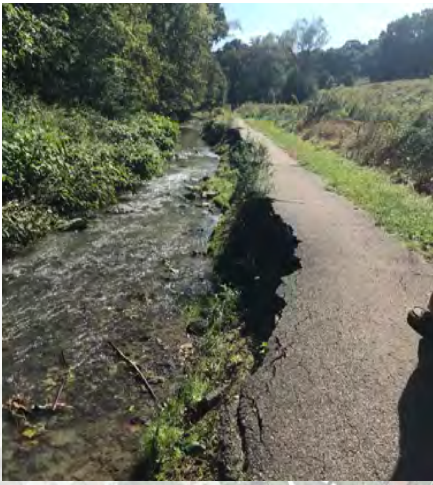
Erosion is degrading former golf cart paths, which were constructed too close to Chalfant Run

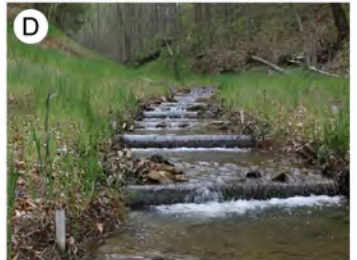
LOG STEP POOL

Different examples of stream restoration techniques

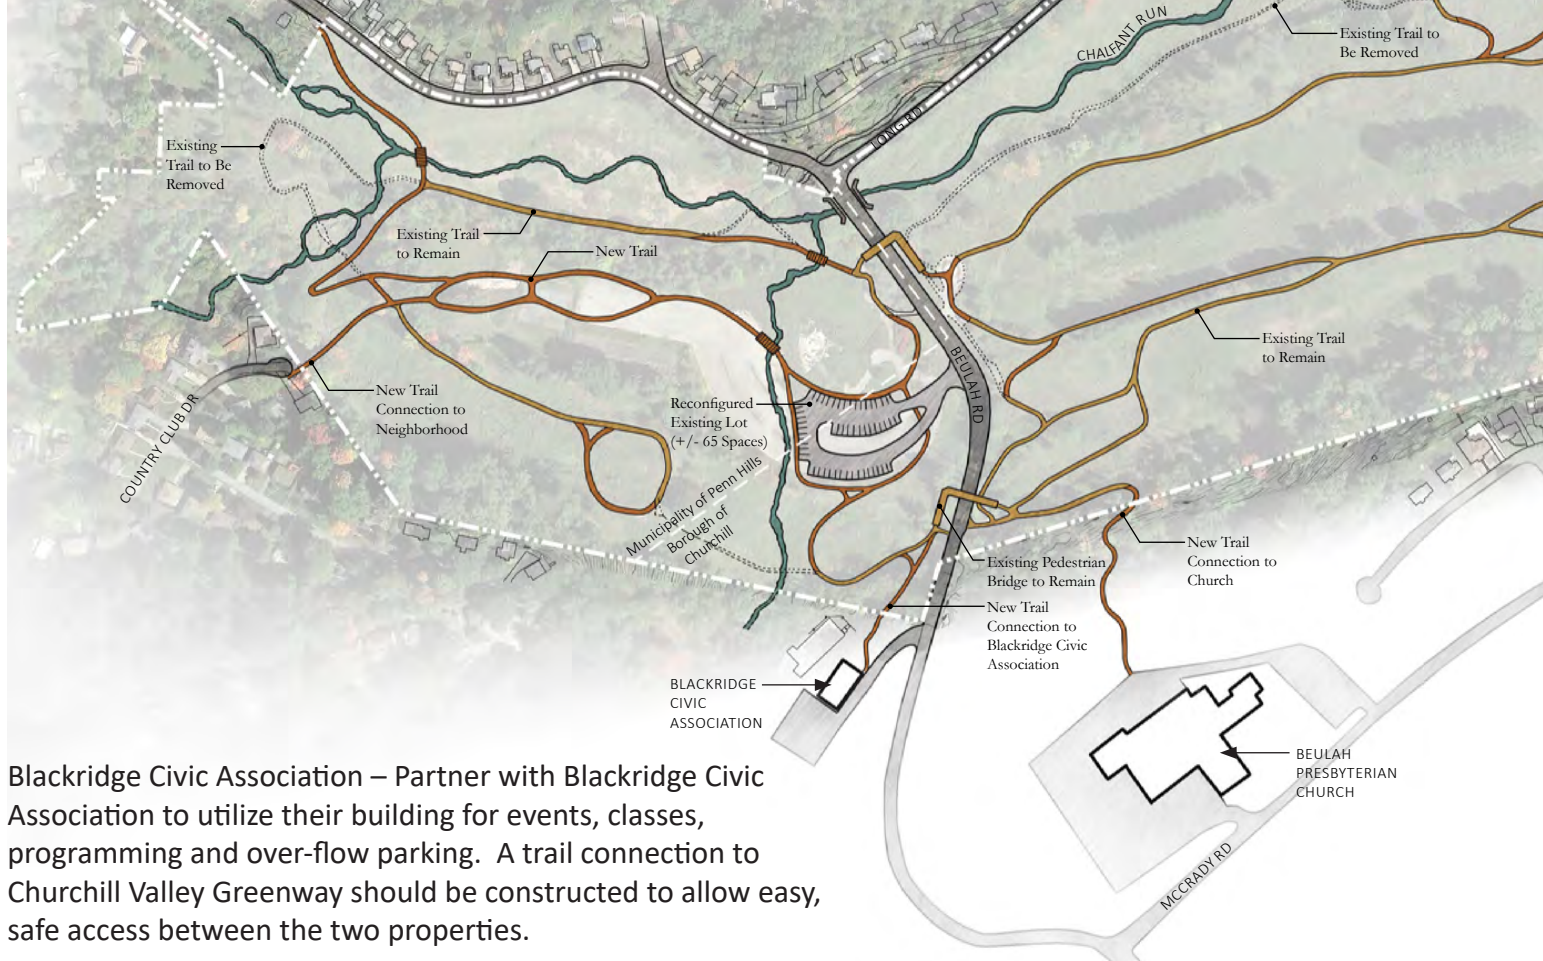
Parking should be consolidated to the western existing lot. New uses that can take advantage of the existing pavement (not needed for parking) should be considered or excess pavement removed. Parking on the east side of Beulah Road should be removed and parking prohibited.

Public Access Points should be limited to controllable, accessible locations, which are: Beulah Road entry and parking, McGrady Road trail head, Beulah Presbyterian Church access, Country Club Drive and Pat Seneca Memorial Field.

Blackridge Civic Association – Partner with Blackridge Civic Association to utilize their building for events, classes, programming and over-flow parking. A trail connection to Churchill Valley Greenway should be constructed to allow easy, safe access between the two properties.

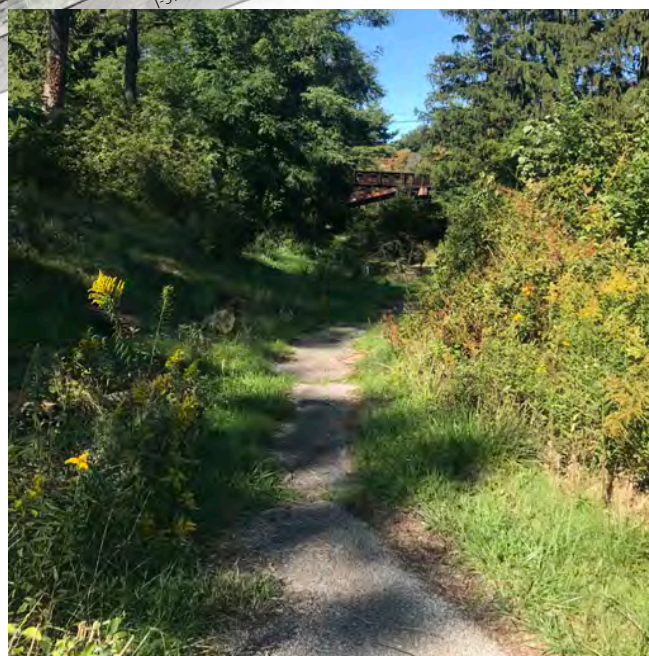
Gently sloping trails are handicap accessible and will remain. The pedestrian bridges (in background) will be rehabilitated for easy pedestrian access over Beulah Road.
