Churchill Valley Greenway

Conceptual Planning Report

January 2022

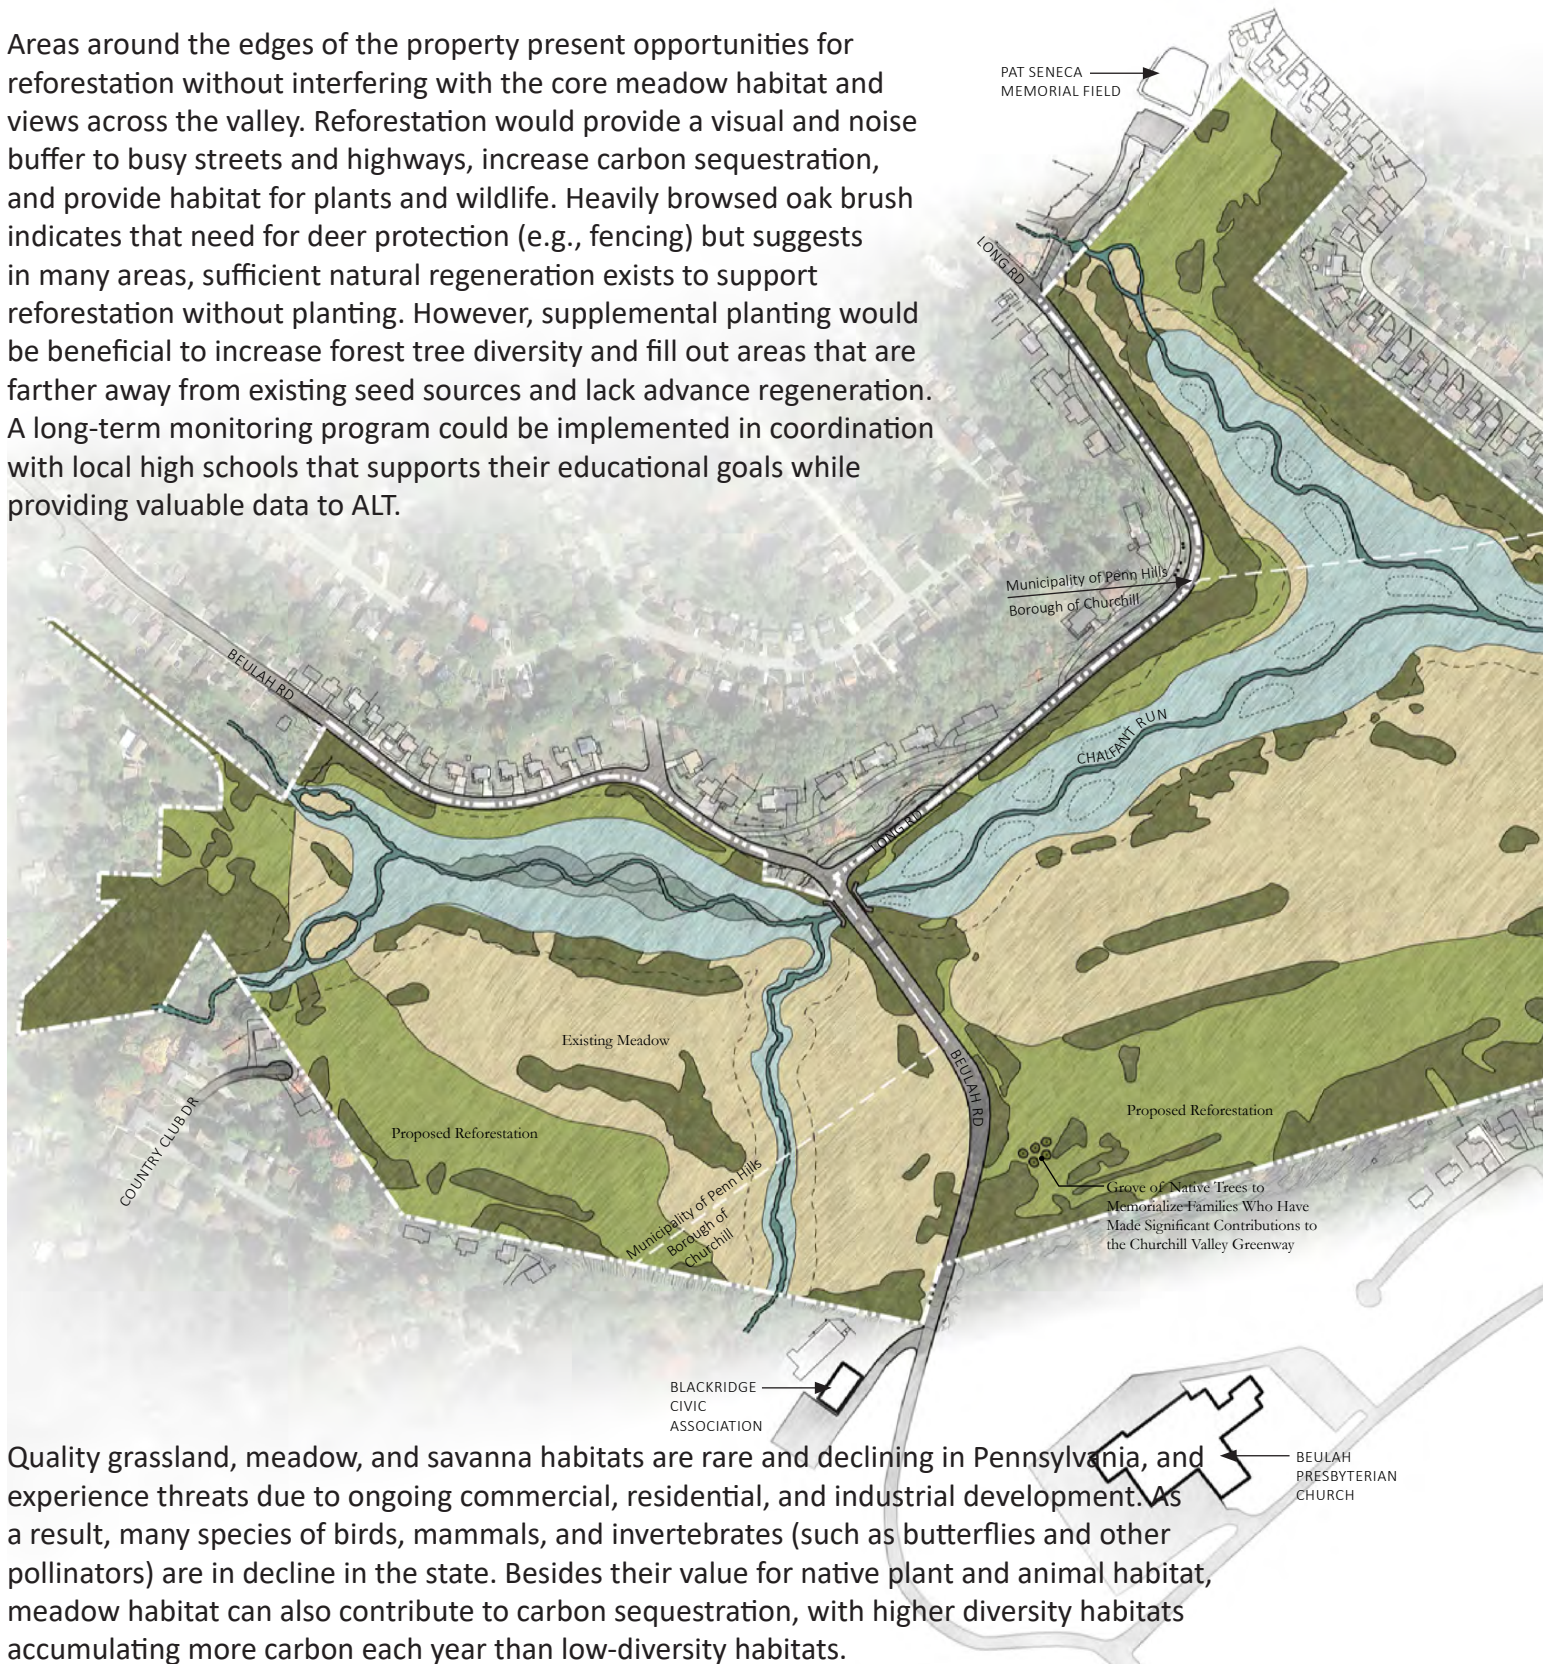
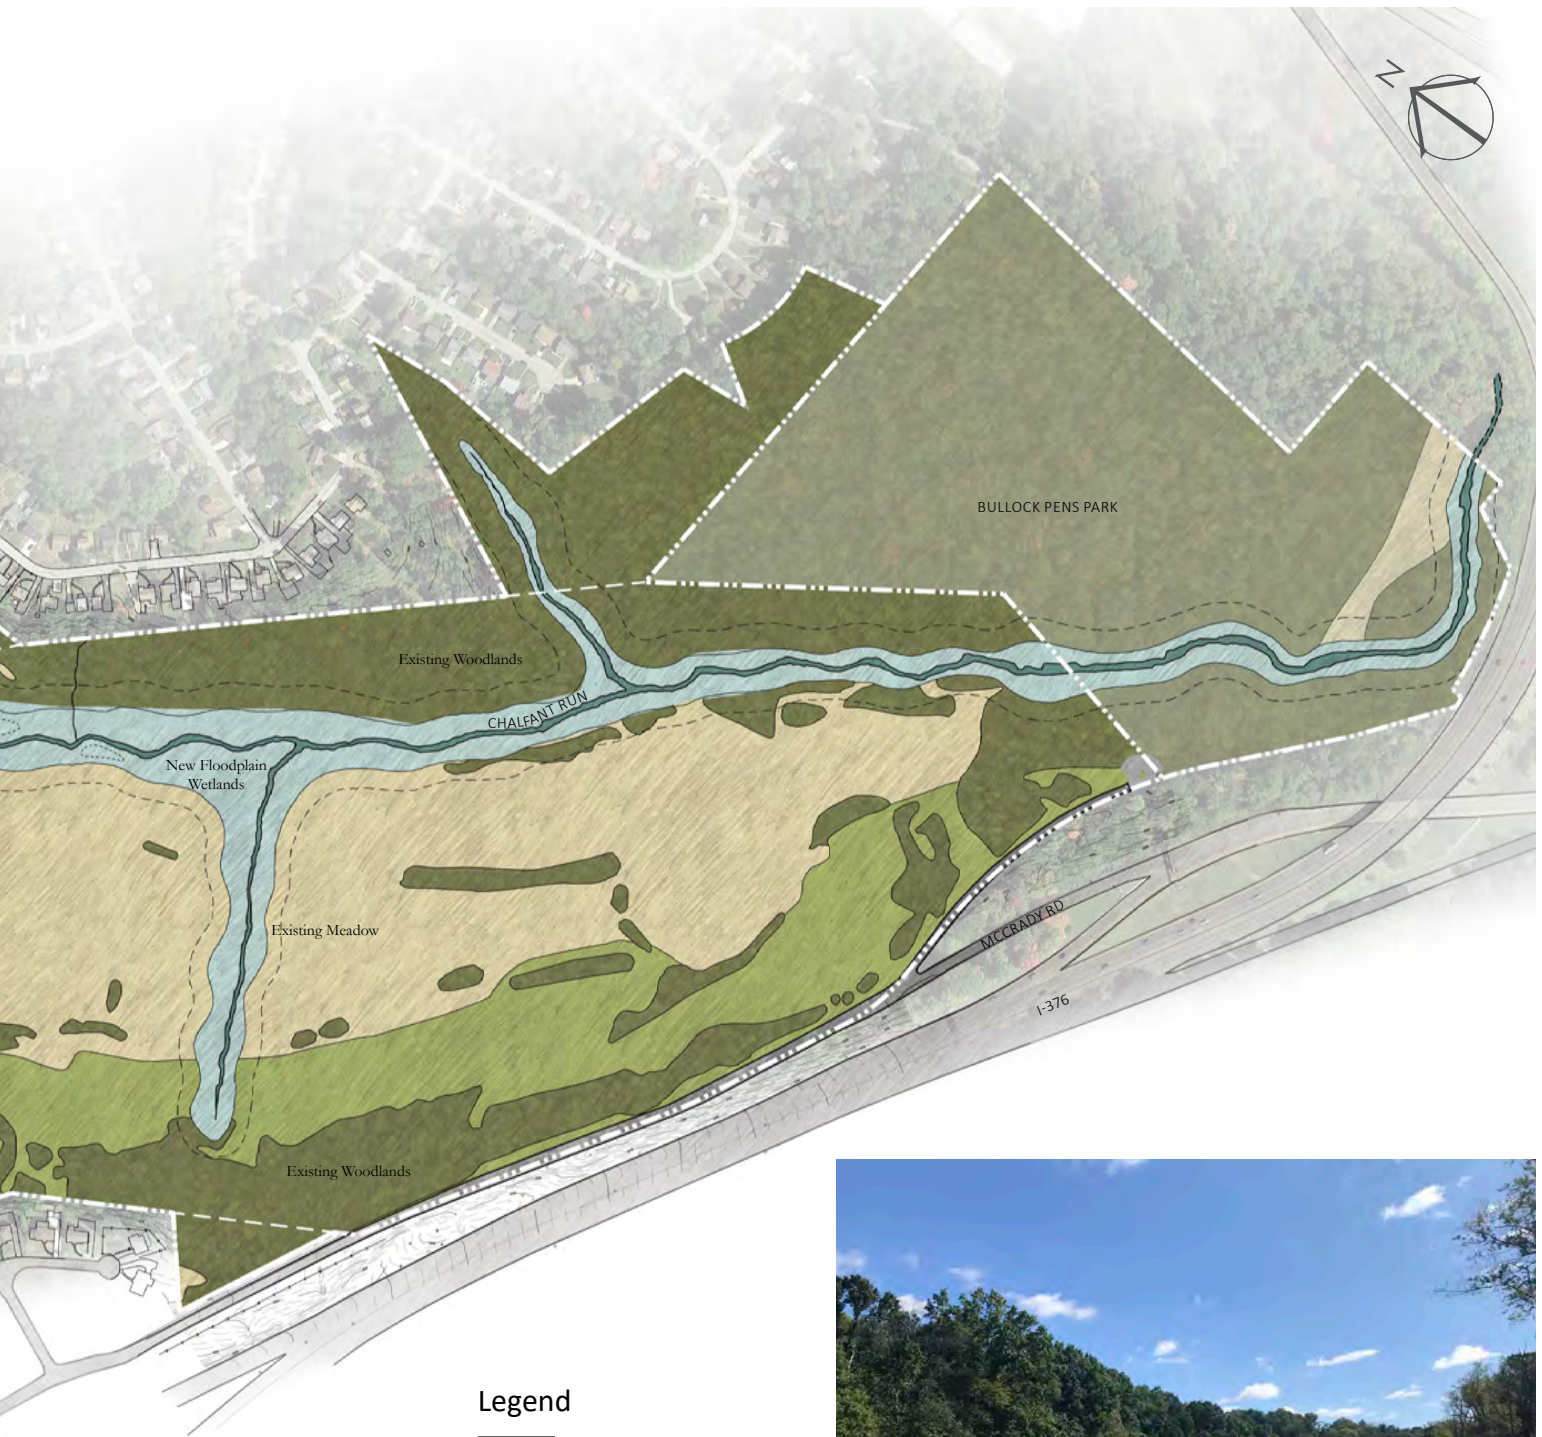
Proposed Reforestation Strategies

Areas around the edges of the property present opportunities for reforestation without interfering with the core meadow habitat and views across the valley. Reforestation would provide a visual and noise buffer to busy streets and highways, increase carbon sequestration, and provide habitat for plants and wildlife. Heavily browsed oak brush indicates that need for deer protection (e.g., fencing) but suggests in many areas, sufficient natural regeneration exists to support reforestation without planting. However, supplemental planting would be beneficial to increase forest tree diversity and fill out areas that are farther away from existing seed sources and lack advance regeneration. A long-term monitoring program could be implemented in coordination with local high schools that supports their educational goals while providing valuable data to ALT.

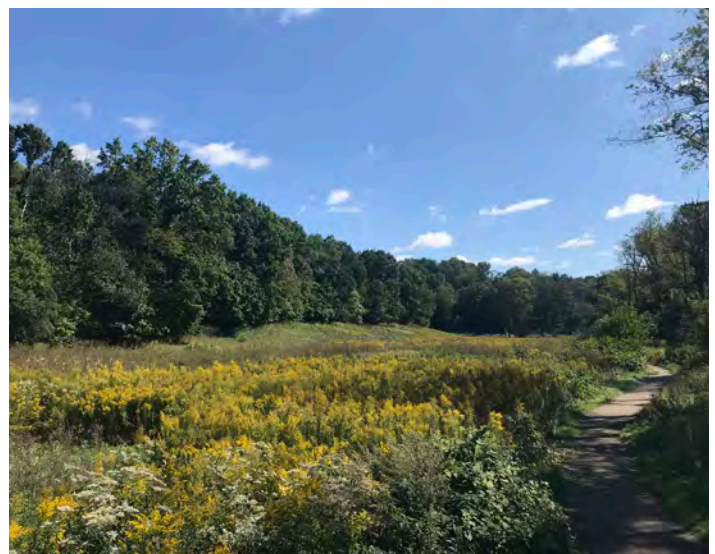
Reforestation efforts should focus on reinforcing the perimeter boundary of the property

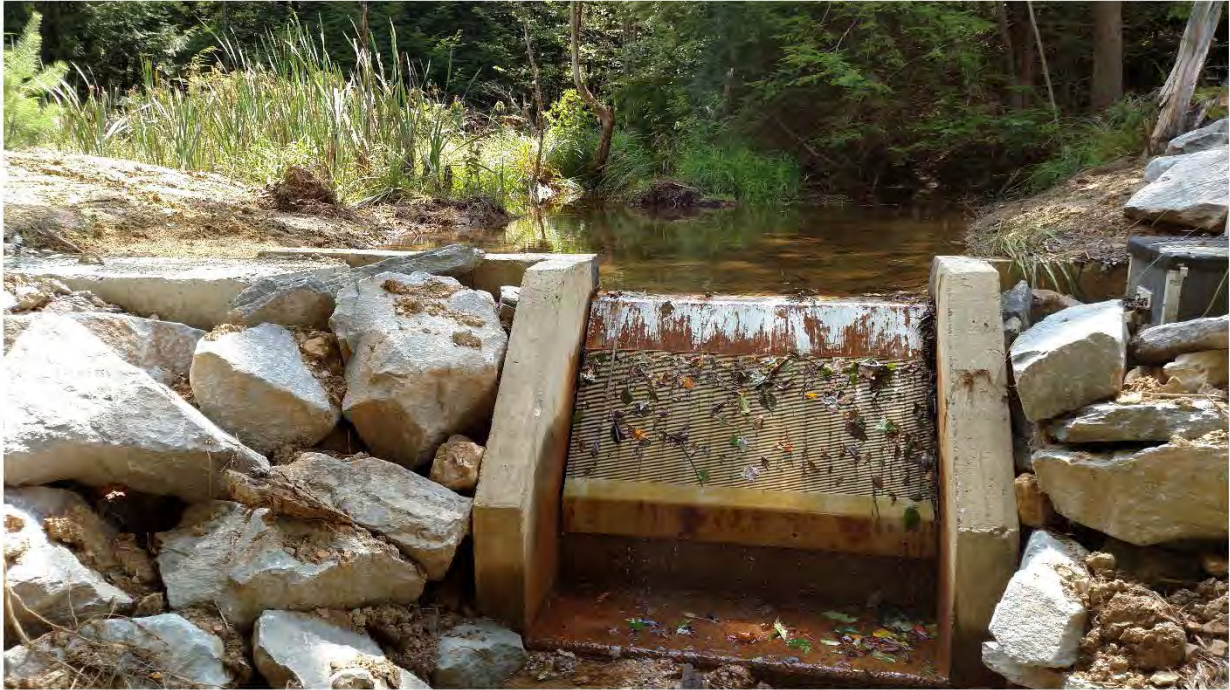
Photo 1. A stream intake structure that collects and diverts a maximum flow of water to a treatment facility while bypassing flow above the maximum. The screen prevents debris from plugging the transfer pipe

Treatment of acid mine water containing aluminum is accomplished by adding alkalinity and removing metals. Since the sources of AMD into the ALT site's waters are intermittently mixed with heavy flows of stormwater runoff and sewage overflow, it will be difficult to isolate the waters for treatment. Despite this limitation, water collection could occur through the use of an in-stream concrete intake structure that allows AMD-contaminated water to enter a treatment system during periods of low-flow, and diluted overflow waters to enter the original channel during storm events. A picture of this type of structure is attached at the end of the report (Photo 1).

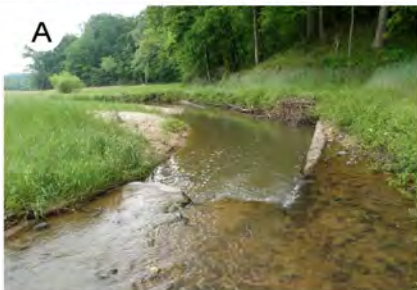
A
LOG J-HOOK

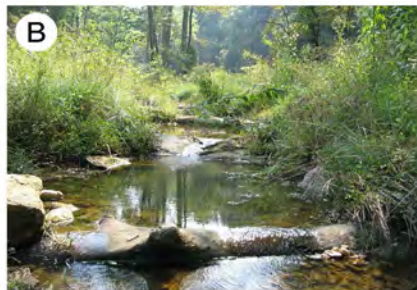
B
LOG & ROCK STEP

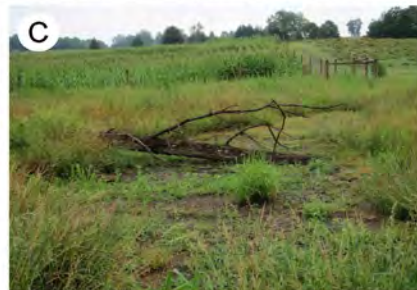
C
WETLAND

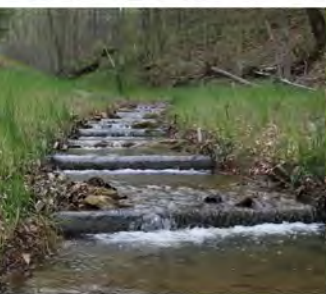
POOL

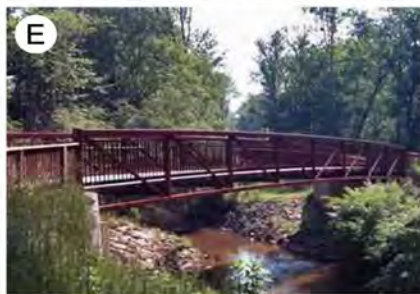
TRAIL CROSSING

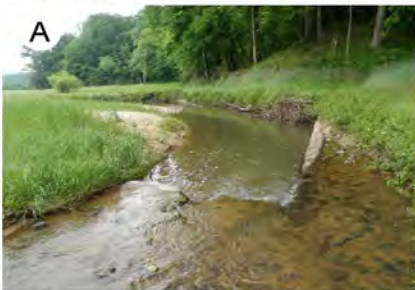
LOG J-HOOK

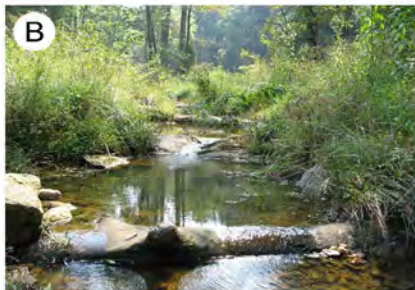
LOG & ROCK STEP
